Shock Pulse and Vibration Monitoring Optimize Hoist Reliability at Boliden

Tim Sundström Renstrom Mine Sweden

The Renström mine hoist case

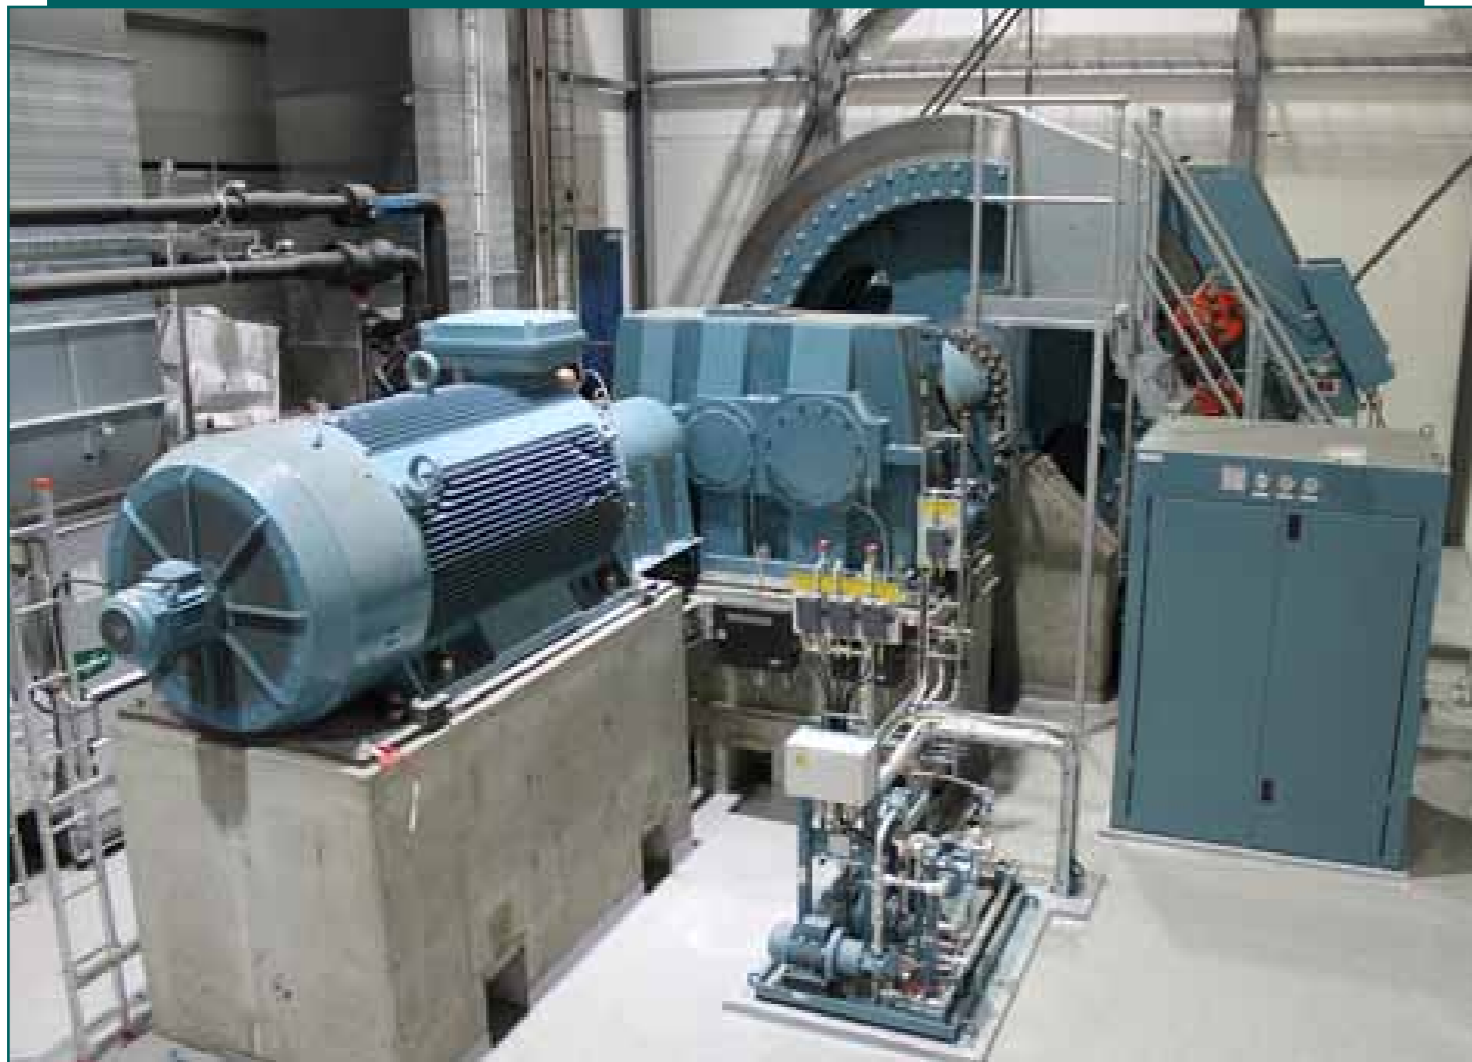
Figure 1 The multi-rope friction hoist at the Renström mine

At the Renström mine in northern Sweden, Boliden successfully monitors the mechanical condition of the multi-rope friction hoist using a combination of vibration and high definition shock pulse measurement. First installed in 1953 in a tower mounted setup, the Renström mine hoist had its second revamp in 2013, converting it to a ground mounted hoist system.

The hoist basically is made up of a frequency controlled motor, a two-stage gearbox, a drum, the wires and two skips. The skips are mounted at the tail end of the wires with a lifting capacity of approximately 5 tons each. Delivered by ABB, the 400 kW motor and gearbox has a total ratio of 13.609:1. Upon installation of the new hoist at Renström in July, 2013, the online system Intellinova Compact with the SPM HD shock pulse measurement technology was also installed and commissioned, providing very good baseline measurements from the brand new hoist.

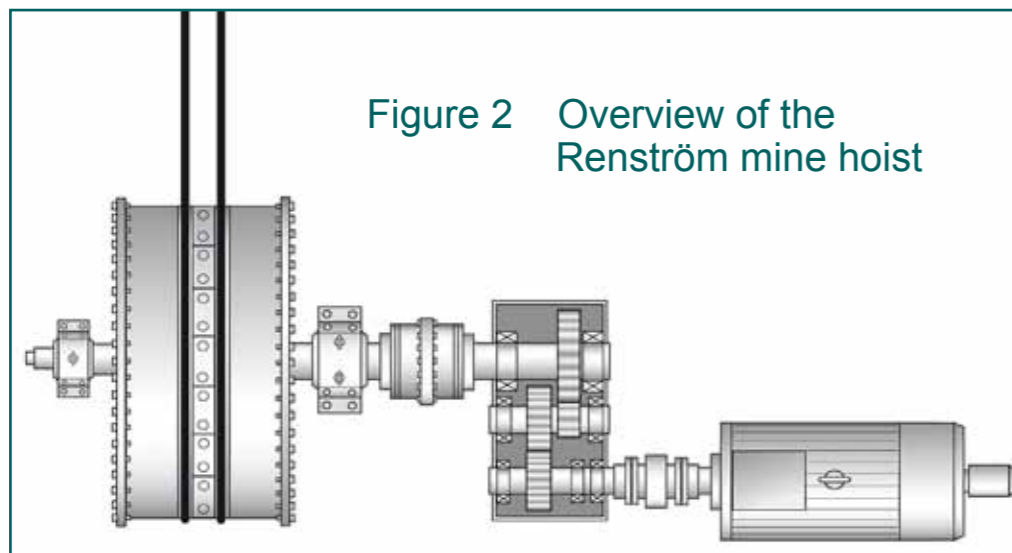
Figure 2 Overview of the Renström mine hoist

Fifteen transducers are used to cover the motor, gearbox and drum; ten shock pulse transducers to monitor bearing condition, and four vibration transducers to detect low frequency vibrations like gear mesh frequencies in the gearbox or unbalance in the drum. In addition, RPM is measured on the motor drive shaft, one pulse per revolution.

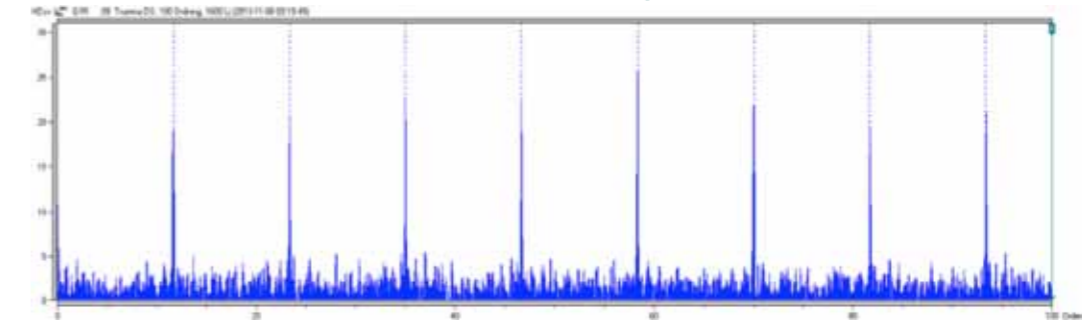
Figure 3 An SPM HD spectrum perfectly matching outer race defect frequencies.

There are also signs of outer race damage on the drive side bearing of the drum (see Figure 3); although still very small, it can be clearly seen in the readings. Measurements also occasionally show relatively high random impacts close to the coupling between gearbox and drum.

The levels are very low with an HDm value of 10 dB. With the exception of these deviations, the hoist is running very smoothly with low and stable readings in general. The suspected unbalance and small bearing defect are closely monitored through continuous measurement and trending.
